Name: Muhammad Anees Khan
Age: 19 Years
Topic: Air Accidents

United Airlines Flight 585:

LAPA Flight 3142:

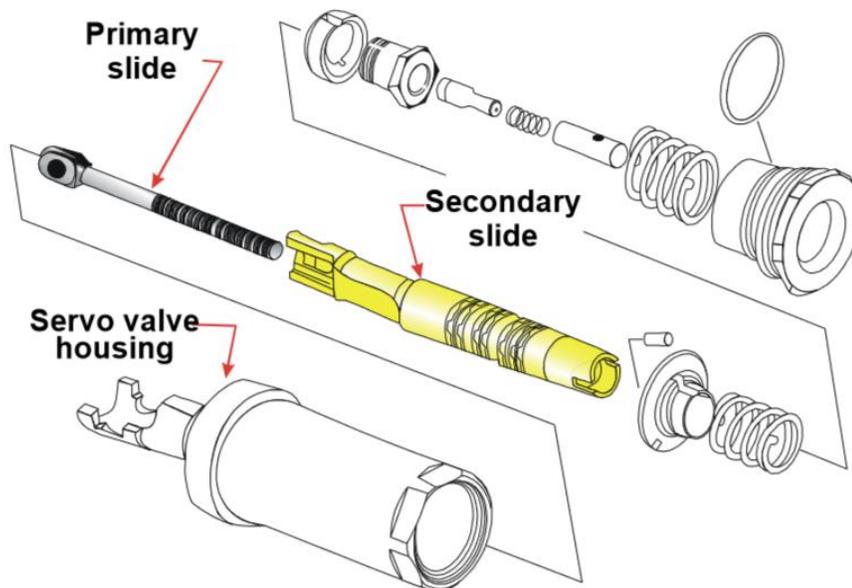
Boeing 737 main rudder PCU servo valve.

These tests revealed that, when the secondary slide was jammed to the servo valve housing at certain positions, the primary slide could travel beyond its intended stop position because of bending or twisting of the PCU's internal input linkages (compliance). This deflection allowed the primary slide to move to a position at which the PCU commanded the rudder in the direction opposite of the intended command (reversal). Specifically, the tests revealed that, when the secondary slide was jammed at positions greater than 50 percent off neutral toward the extend or retract position and a full-rate command was applied to the PCU, the rudder would move opposite to the commanded position. So anytime the pilot tries to correct the rollover by applying the opposite rudder the condition only became more and more worst.

This phenomenon was found to be **the cause** for the crash of United Airlines Flight 585.

Boeing redesigned and replaced the servo valve on every 737 around the globe to reduce the threat of rudder reversal.

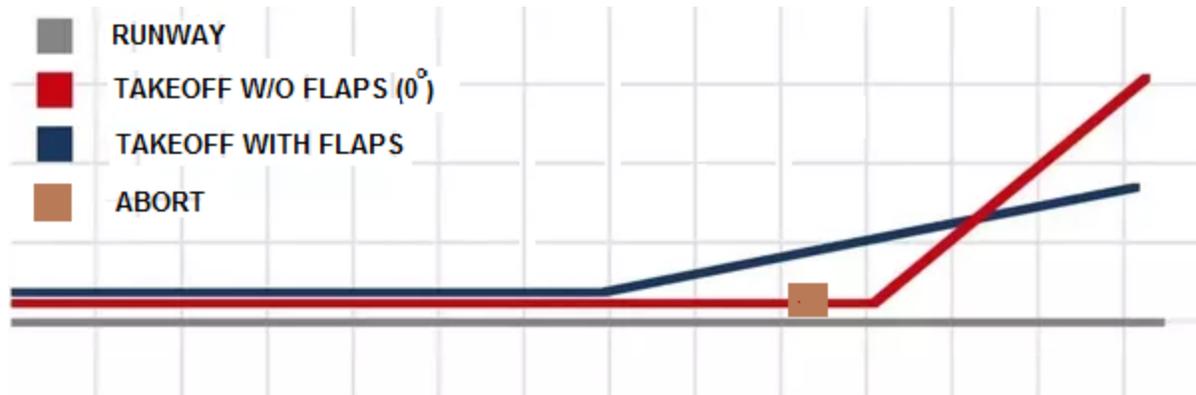
In the case of LAPA Flight 3142, the speeds V_1 , V_r and V_2 were calculated by the pilots prior to flight and in those calculations the flaps were assumed to be set for takeoff. So if the rotation speed is to be calculated with flaps set to 0° it would lie farther ahead on the runway. As illustrated in the Figure.

So the Cockpit Crew did not know that their flaps were at 0° and they were expecting the airplane to lift off according to their calculations. So when they rotate the airplane it could not leave the ground, because the wing needed more airspeed to provide the necessary lift for climb and they were perplexed by this behavior of the airplane. So they decided to abort the takeoff without developing the necessary airspeed required to takeoff with 0° Flaps Position. The captain tried everything to stop the airplane from overshooting the runway by arming the spoilers, using the reverse thrust at its max settings and applying the brakes. However the moment they took the decision to abort they had crossed V_1 and it was too late to bring the airplane to a complete stop on the runway.
